Analysis of surface blistering in the manufacturing of faucets*

Picha Panmongkol¹, and Noppakorn Phuraya^{2*}¹ Department of Mechanical Engineering, Faculty of Engineering,
Thonburi University, Nong Khaem, Bangkok, 10160 Thailand² Department of Industrial Engineering, Faculty of Engineering,
Mahidol University, Phutthamonthon, Nakorn Pathom, 73170 Thailand

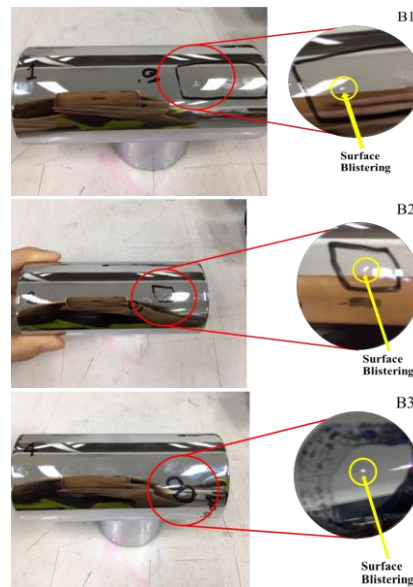
The results of the macroscopic observations performed on specimens B1, B2, and B3 found surface blistering with a size of around 1 mm, after electroplating and polishing to make the surface shiny and have the desired properties. There were 3 layers of coating: copper, nickel, and chromium. The surface blistering is shown in Figure 2.

Figure 2. Results of visual examination showing the surface blistering on specimens B1, B2, and B3

In the case of surface blistering on a faucet, the process involves compressing the air within a high-pressure die-cast machine and ejecting the component from the mold using mechanisms such as a vacuum valve, overflow system, or vent. Any residual air present inside the casting dissolves uniformly into the molten metal. The turbulence within the process can lead to localized air concentrations, resulting in high-pressure cavities. After electroplating the faucet also undergoes heating, causing any accumulated air beneath the applied coating to escape. This release of trapped air can lead to blisters on the faucet surface (Dybowski, Kielbus, & Poloczek, 2023).

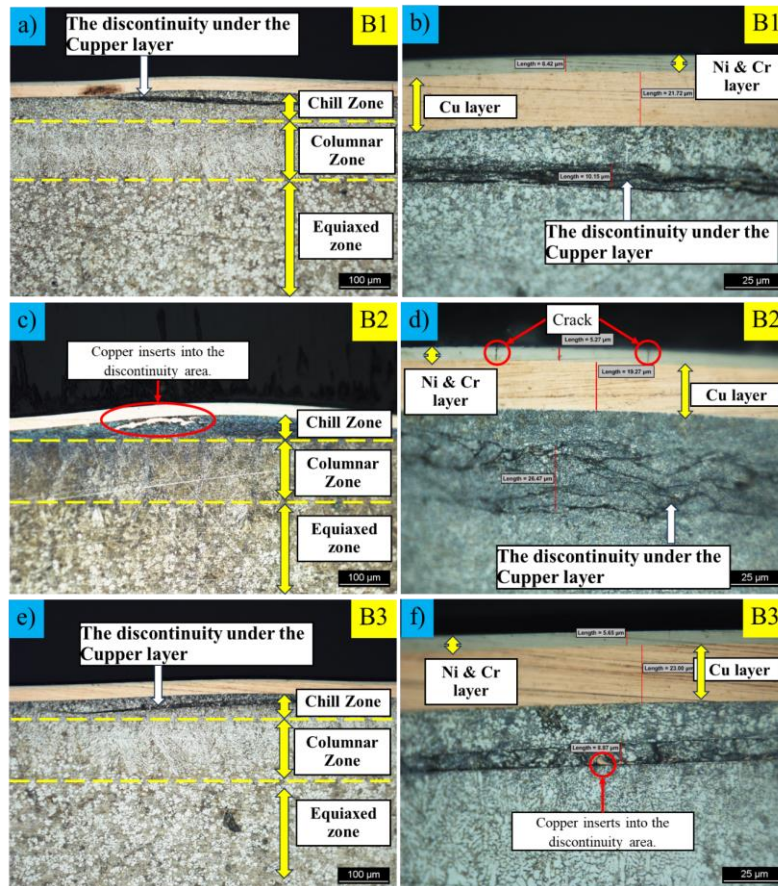
The typical microstructure of specimens in Figures 3 (a, c, and e) illustrates that the chill zone of a workpiece features fine grains. Deeper within the material, dendritic grains are evident in the columnar zone. As we progress towards the center of the workpiece, known as the equiaxed

Figures 3 (b, d, and f) reveal a coating consisting of two layers. The first layer is copper, with thicknesses of 21.72, 19.27, and 23.00 micrometers, respectively. On top of this layer lies another composed of nickel and chromium, measuring 6.42, 5.27, and 5.65 micrometers in thickness, respectively. Additionally, there is a discontinuity layer, situated beneath the copper layer, also having copper inserts into the discontinuity area and cracks at the Ni and Cr layers. The crack arises from localized plastic strains occurring at different temperatures during the electroplating (Ozhoga-Maslovskaja, Gariboldi, & Lemke, 2016).

Figure 3. Cross-sections of blistered specimens B1, B2, and B3

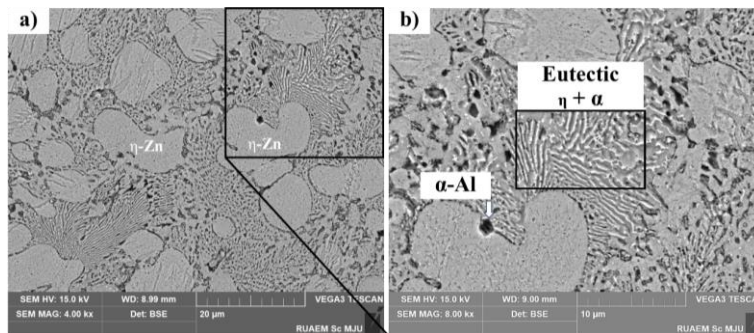
Figure 4 illustrates the detailed microstructure of the as-annealed sample, characterized by back-scattering electrons (BSE). As depicted in Figure 4 (a), the microstructure reveals the presence of η -Zn, while Figure 4 (b) highlights the eutectic phase consisting of fine Zn and Al phases (Hasan, Sharif, & Gafur, 2020; Liang, Wu, Sandl obes, Korte-Kerzel, & Schmid-Fetzer, 2019). The Zn matrix is observed to contain fine α -Al phases. Al particles with varying sizes form under different conditions: specifically, the eutectic-phase Al particles crystallize at high temperatures, while ultrafine-grained Al particles precipitate in the Zn matrix during cooling that decreases solubility (Pola, Tocci, & Goodwin, 2020).

Figure 4. Typical morphology of the base material (specimen B1): (a) η -Zn phase, and (b) α -Al particles and the eutectic lamellar morphology ($\eta + \alpha$)

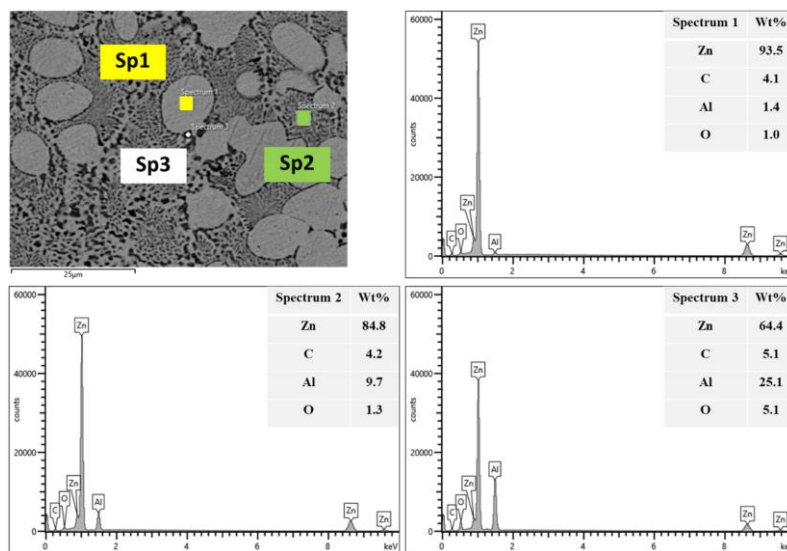
Figure 5 displays the SEM-EDS results of the base material (specimen B1). Upon closer examination, several distinct phases were identified through point analysis. The Spectrum 1 area is η -Zn-rich, characterized by round, white regions distributed along the grain boundaries. Spectrum 2, analyzed over an area, displays a eutectic structure consisting of the two phases η -Zn and α -Al. Quantitative elemental analysis techniques were employed to determine the compositions of these phases: 1) The η -Zn phase (Pola, Tocci, & Goodwin, 2020) is identified as a phase with a substantial amount of zinc dissolved in the form of a solid solution, constituting a zinc-rich solid solution. This phase has a higher quantity of zinc than what is proportionally expected based on the total weight of zinc in the workpiece. 2) Conversely, the α -Al phase contains a relatively high concentration of aluminum dissolved in the form of a solid solution mixed with zinc (Pola, Tocci, & Goodwin, 2020). It was also observed that the amount of aluminum element in this phase was higher than what would be expected proportionally based on the total weight of the aluminum element in the workpiece (Pola, Tocci, & Goodwin, 2020).

(EDS) analysis may be attributed to the die lubricant agents on the mold surface. It has been reported that such reactions occur during die-casting. For example, if the lubricant agent is octadecane, the reaction would be $C_{18}H_{38} = 18C + 19H_2$. This reaction illustrates the generation of carbon and molecular hydrogen. Carbon remains effective as a barrier for the melt, and the hydrogen contributes to the development of internal porosity (Reveko & Moller, 2018).

Figure 5. SEM-EDS results for the base material (specimen B1)

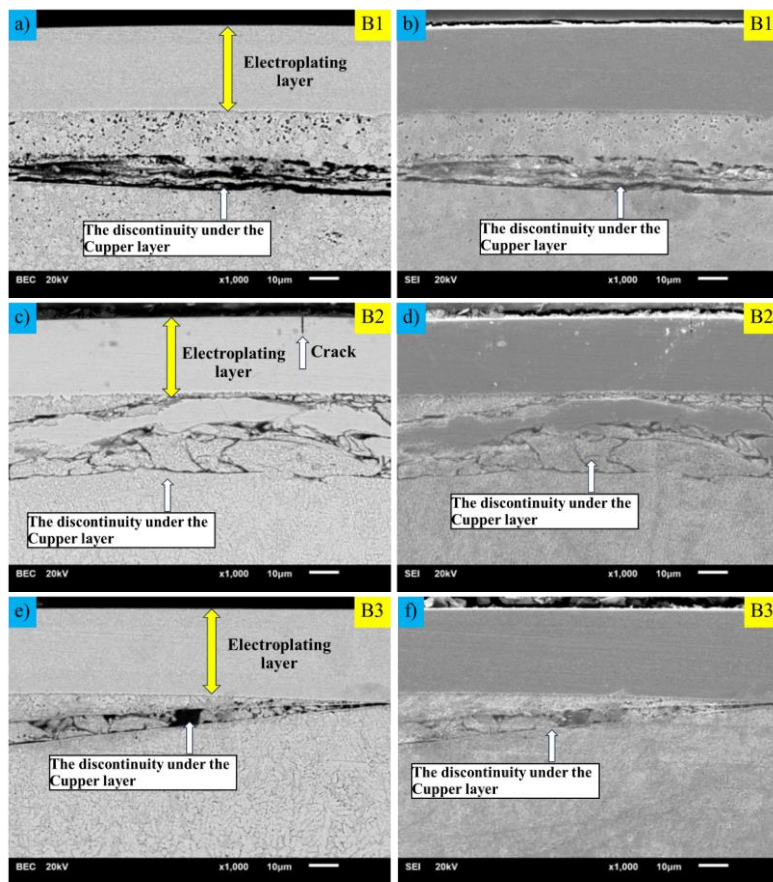
The microstructures of specimens B1, B2, and B3 were examined using scanning electron microscopy, and the results are presented in Figure 6. In all three specimens, discontinuities were identified beneath the coating surface. Figures 6 (a), (c), and (e) are images obtained through backscattered electron imaging (BEI), which enhances the contrast between elements with different atomic numbers, allowing for a clear visualization of the grain characteristics in each structure. On the other hand, Figures 6 (b), (d), and (f) display secondary electron images (SEI). These provide depth-of-field information, enabling the identification of areas where discontinuities, such as hollow regions, are present, making it possible to analyze the elemental composition of both the bulging surface and the discontinuities within the blistering surface.

Figure 6. SEM (BEC and SEI) results for the specimens B1, B2, and B3

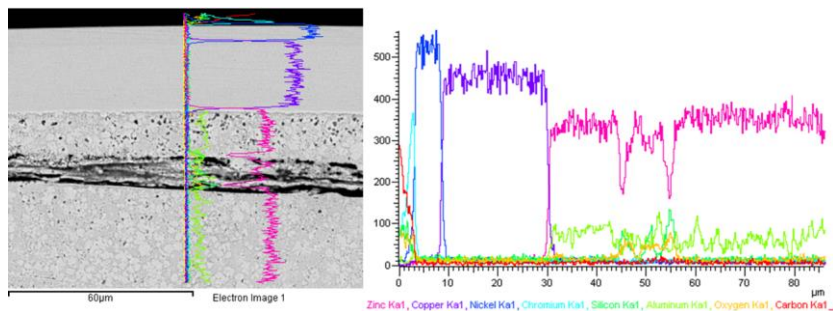
Figure 7 reveals the elemental content of the workpiece by applying a line scan at the surface blistering, which found that the amount of zinc decreased suddenly in the area of the blistering surface, indicating that the material had disappeared from that area and a gap had formed. Elemental analysis using linear scan also confirmed that the coating had three layers comprised of chromium, nickel, and copper, with the respective layers having thicknesses of approximately 3 micrometers, 6 micrometers, and 21 micrometers.

Figure 7. Graph showing the proportions of elements in the surface blistering area
