## **Analysis of Surface Blistering in the Manufacturing of Faucets**

This research aimed to carry out an analysis of the surface blistering problem involved in the manufacturing process for faucets. Zamak 3 is a raw material produced by using a high-pressure die-casting process. The surface blistering microstructure was examined with an optical microscope and scanning electron microscope, while gas properties were examined by using the gas chromatography technique. The results from optical and scanning electron microscopy showed that discontinuities occur in the zinc layer, including a large amount of porosity spreading all over the product on the surface of the zinc layer as well as blistering under the surface. The gas chromatography results showed that the average amount of hydrogen gas was 0.00755 percent per gram, assuming that the discontinuities are caused by the porosity containing gas inside the base metal surface and the heat that occurs during the process of liquid metal injection is the main factor driving gas expansion which affects the discontinuities.

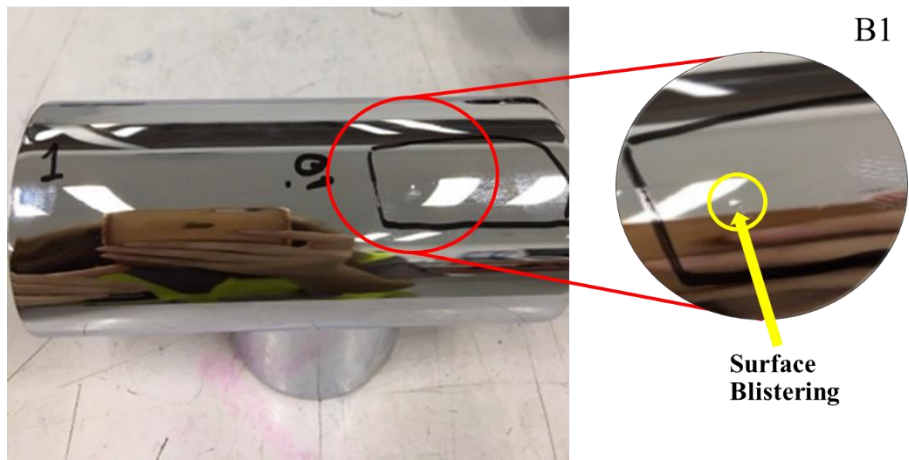
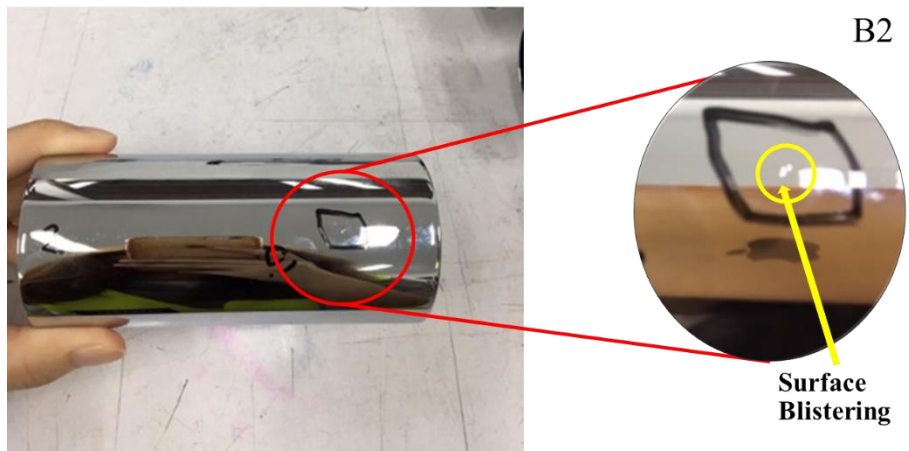
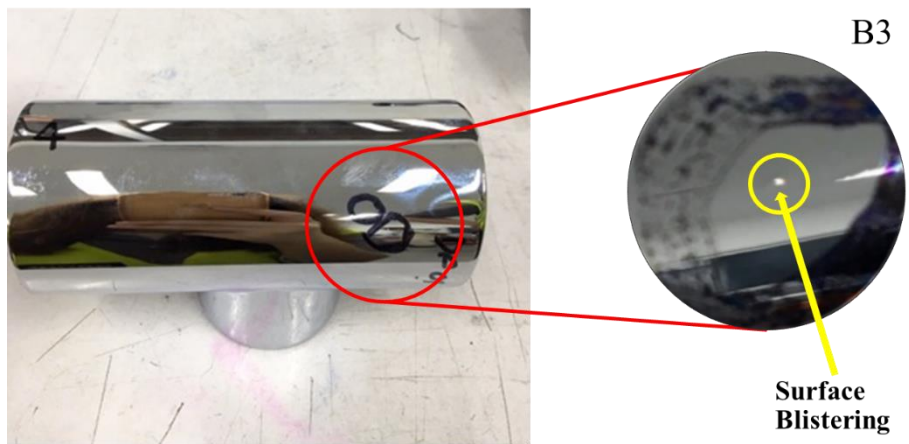
**Figure 2. Results of visual examination showing the surface blistering on specimens B1, B2, and B3**

The results of the macroscopic observations performed on specimens B1, B2, and B3 found surface blistering with a size of around 1 mm, which was found after electroplating and polishing to make the surface shiny and have the desired properties. The coating process has 3 layers of coating: copper, nickel, and chromium, respectively. The surface blistering is shown in Figure 2.

In the case of surface blistering on a faucet, the process involves compressing the air within a high-pressure die-cast machine and ejecting the component from the mold using mechanisms such as a vacuum valve, overflow system, or vent. Any residual air present inside the casting dissolves uniformly into the molten metal. The air turbulence within the process can lead to localized air concentration, resulting in high-pressure cavities. After the electroplating process, the faucet also undergoes heating, causing any accumulated air beneath the applied coating to escape. This release of trapped air can lead to the formation of blisters on the faucet surface. (Dybowski, Kielbus, & Poloczek, 2023)

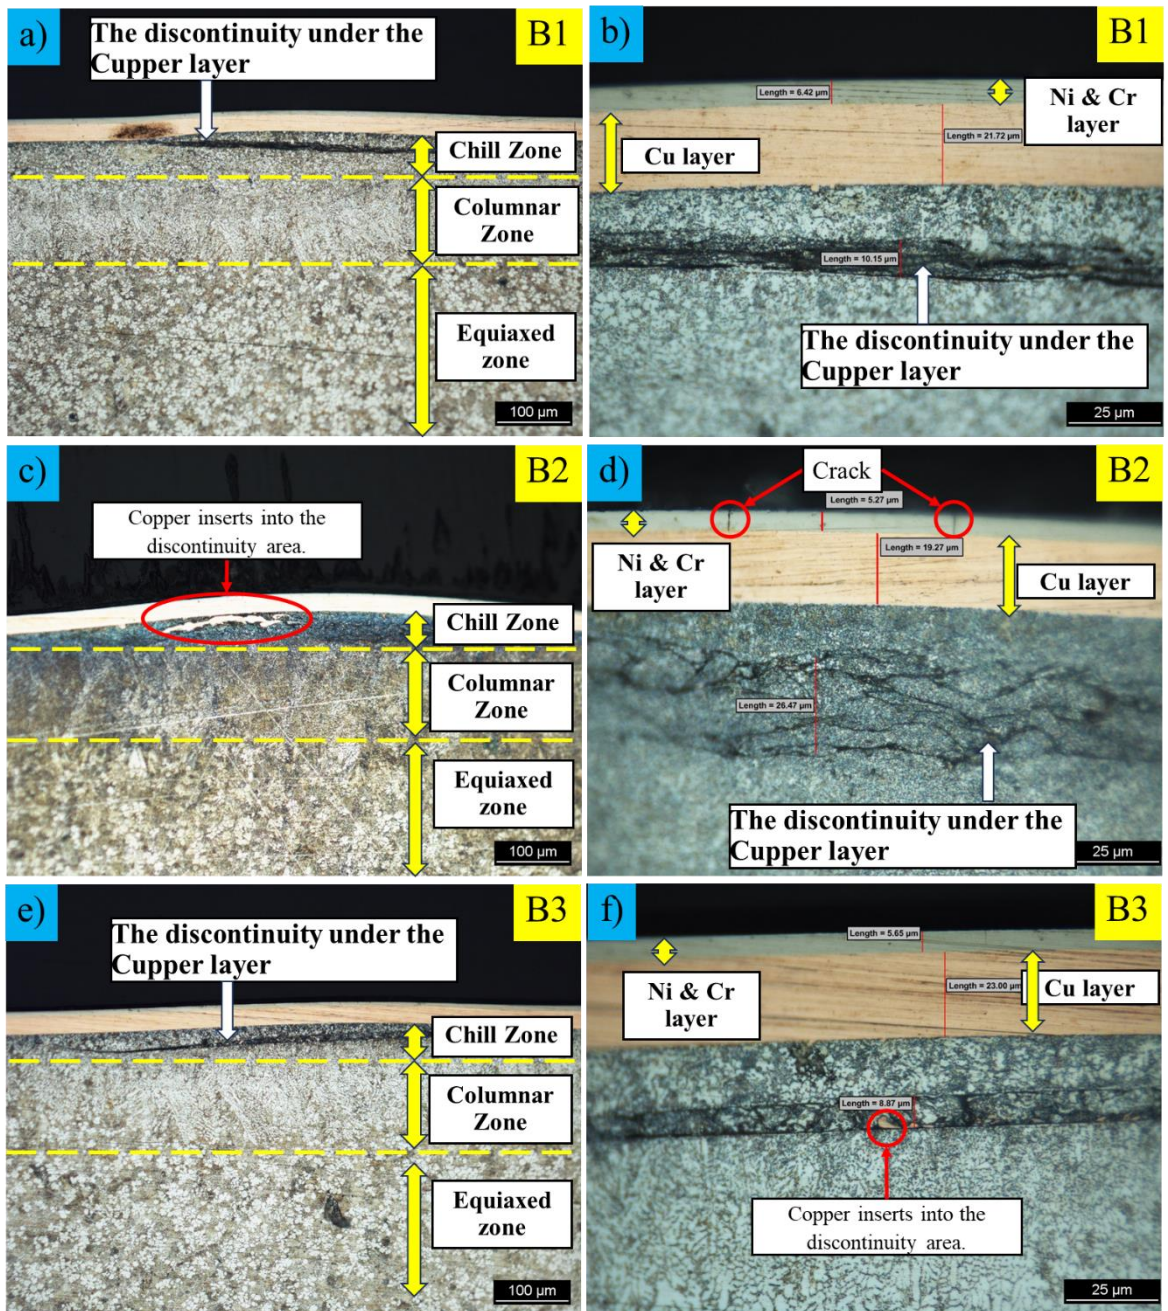
Figure 3. The cross-sections of blistered specimen B1, B2, and B3.

The typical microstructure of specimens in Figures 3 (a, c, and e) illustrates that the chill zone of a workpiece features fine grains. Deeper within the material, dendritic grains are evident in the columnar zone. As we progress towards the center of the workpiece, known as the equiaxed zone, the grains maintain a rounded shape similar to those near the surface, though they are larger in size. (Ares, & Schvezov, 2007; Zhang, Shortle et al., 2019; Ares, & Gassa, 2012)

Figures 3 (b, d, and f) revealed a coating consisting of two layers. The first layer is copper, with thicknesses of 21.72, 19.27, and 23.00 micrometers, respectively. On top of this layer lies another layer composed of nickel and chromium, measuring 6.42, 5.27, and 5.65 micrometers in thickness, respectively. Additionally, there is a discontinuity layer, situated beneath the copper layer, and also found copper inserts into the discontinuity area and cracks at the Ni and Cr layers. This crack arises from localized plastic strains occurring at different temperatures during the electroplating process. (Ozhoga-Maslovskaja, Gariboldi, & Lemke, 2016).

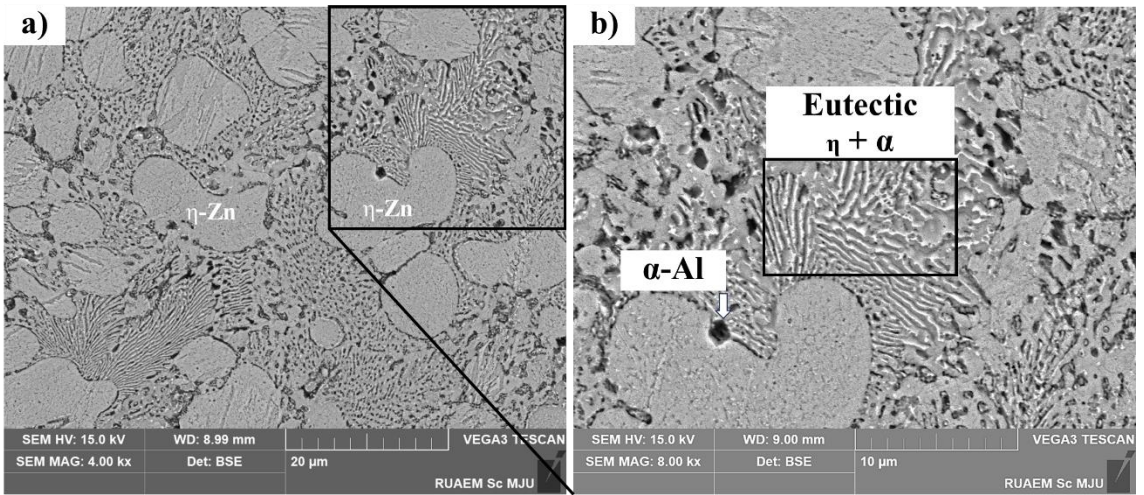
**Figure 4 Typical morphology of the base material (specimen B1): (a)  $\eta$ -Zn phase (b)  $\alpha$ -Al particles and the eutectic lamellar morphology ( $\eta + \alpha$ ).**

Figure 4 illustrates the detailed microstructures of the as-annealed sample, characterized by back-scattering electrons (BSE). As depicted in Figure 4 (a), the microstructure reveals the presence of  $\eta$ -Zn, while Figure 4 (b) highlights the eutectic phase consisting of fine Zn and Al phases (Hasan, Sharif, & Gafur, 2020; (Liang, Wu, Sandlöbes, Korte-Kerzel, & Schmid-Fetzer, 2019). The Zn matrix is observed to contain fine  $\alpha$ -Al phases are depressively. Al particles with varying sizes form under different conditions; specifically,

the eutectic-phase Al particles crystallize at high temperatures, while ultrafine-grained Al particles precipitate in the Zn matrix during cooling, attributed to decreased solubility (Pola, Tocci, & Goodwin, 2020).

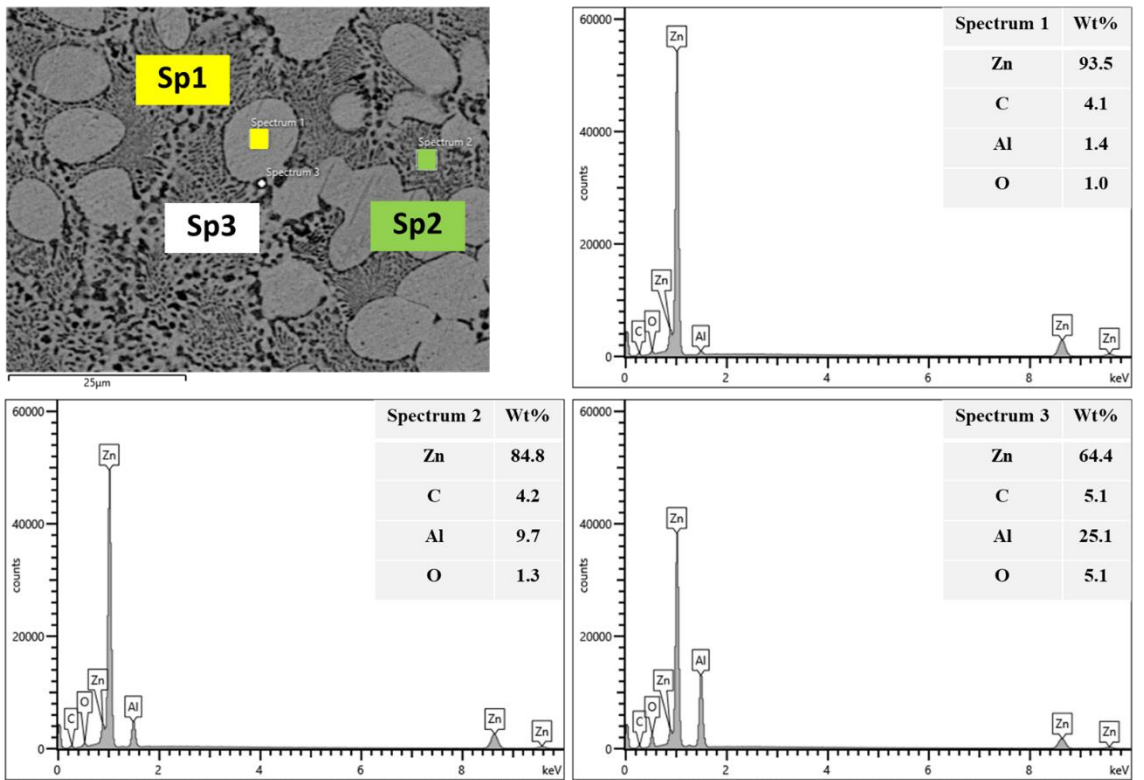
**Figure 5. SEM-EDS results for the base material (specimen B1).**

Figure 5 displays the SEM-EDS results of the base material (specimen B1). Upon closer examination, several distinct phases were identified through point analysis. The Spectrum 1 area exhibits the  $\eta$ -Zn-rich, characterized by round, white regions distributed along the grain boundaries. Spectrum 2, analyzed over an area, displays a eutectic structure consisting of two phases intermixed between the  $\eta$ -Zn phase and the  $\alpha$ -Al phase. Quantitative elemental analysis techniques were employed to determine the composition of these phases: 1) The  $\eta$ -Zn phase (Pola, Tocci, & Goodwin, 2020) is identified as a phase with a substantial amount of zinc dissolved in the form of a solid solution, constituting a zinc-rich solid solution. This phase has a higher quantity of zinc than what is proportionally expected based on the total weight of zinc in the workpiece. 2) Conversely, the  $\alpha$ -Al phase contains a relatively high concentration of aluminum dissolved in the form of a solid solution mixed with zinc. (Pola, Tocci, & Goodwin, 2020) It was also observed that the amount of aluminum element in this phase was higher than what would be expected proportionally based on the total weight of the aluminum element in the workpiece. (Pola, Tocci, & Goodwin, 2020)

The presence of carbon suggests an active role in contamination within the microstructure. The quantitative measurement of carbon in the Energy Dispersive X-ray Spectroscopy (EDS) analysis may be attributed to the die lubricant agents on the mold surface. It has been reported that the formation of the reaction occurs during the die-casting process. For example, if the lubricant agent is octadecane, the reaction would be  $C_{18}H_{38} = 18C + 19H_2$ .

This reaction illustrates the generation of carbon and molecular hydrogen. Carbon remains effective as a barrier for the melt, and hydrogen additionally contributes to the development of internal porosity. (Reveko & Moller, 2018)

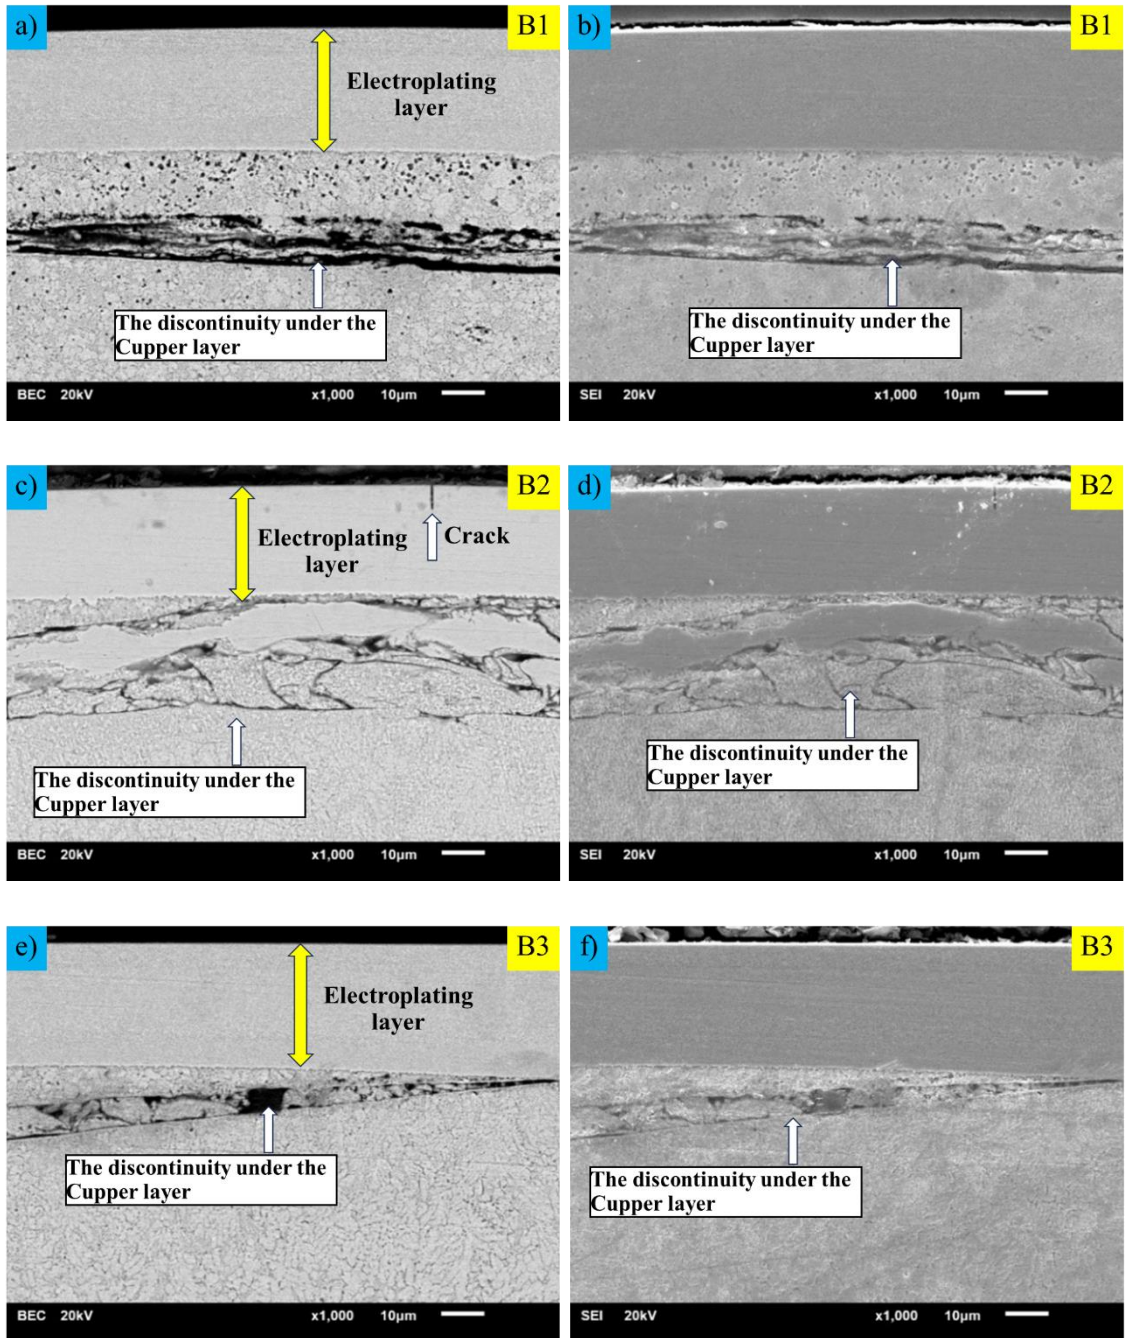
Figure 6. SEM (BEC and SEI) results of the specimen B1, B2, and B3.

The microstructures of specimens B1, B2, and B3 were examined using scanning electron microscopy, and the results are presented in Figure 6. In all three specimens, discontinuities were identified beneath the coating surface. Figures 6 (a), (c), and (e) are images obtained through backscattered electron imaging (BEI), which enhances the contrast between elements with different atomic numbers, allowing for a clear visualization of the grain characteristics in each structure. On the other hand, Figures 6 (b), (d), and (f) display secondary electron images (SEI). These images provide depth-of-field information, enabling the identification of areas where discontinuities, such as hollow regions, are present, making it possible to analyze the elemental composition of both the bulging surface and the discontinuities within the blistering surface.

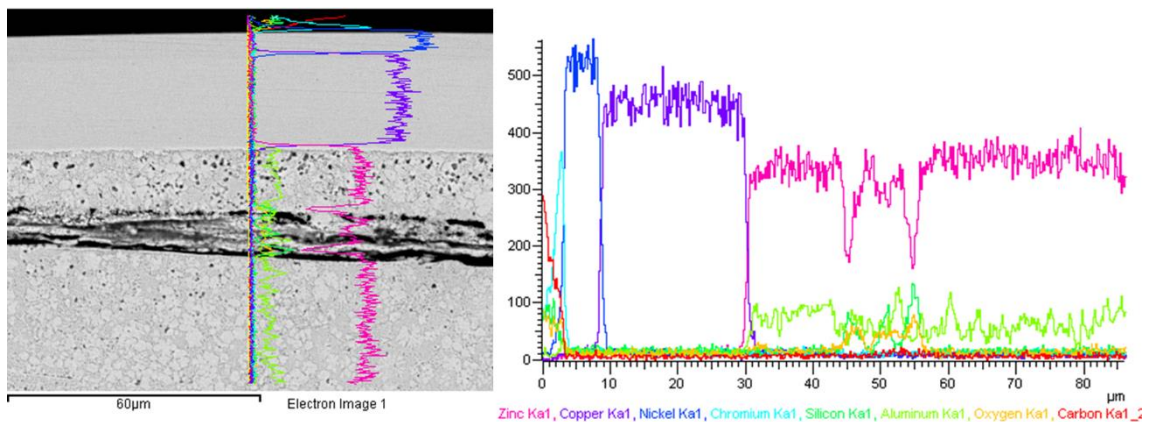
**Figure 7. Graph showing the number of elements in the surface blistering area**

Figure 7 reveals the elemental content of the workpiece by applying a line scanning technique to the surface blistering, which found that the amount of zinc decreased suddenly in the area of the blistering surface, which indicated that the material had disappeared in that area and a gap had formed. Elemental analysis using linear scanning techniques also confirmed that the coating had three layers comprised of chromium, nickel, and copper, with each layer having a thickness of approximately 3 micrometers, 6 micrometers, and 21 micrometers, respectively.
