Cyclic behavior of non-seismically designed interior reinforced concrete beam-column connections

Amorn Pimanmas¹ and Teeraphot Supaviriyakit^{2*}

This paper presents a test of non-seismically detailed reinforced concrete beam-column connections under reversed cyclic load. The tested specimens represented those of the actual mid-rise reinforced concrete frame buildings, designed according to the non-seismic provisions of the ACI building code. The evaluation of 10 existing reinforced concrete frames was conducted to identify key structural and geometrical indices. It was found that there existed correlation VS structural and geometrical characteristics and the column tributary area. Hence, the column tributary area was chosen as a parameter for classifying the specimens. The test results showed that specimens representing small and medium column tributary area failed by brittle joint shear, while specimen representing large column tributary area failed by ductile flexure, even though no ductile seismic details were provided.

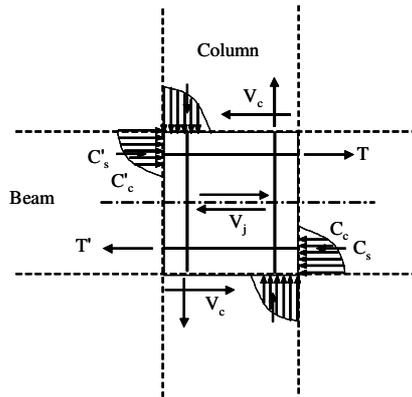
As a result of the lack of seismic consideration in structural design, the reinforcement details of these frame buildings were usually weak against earthquake loading. The beam-column joint is one of the most critical components in the seismic load path. Under lateral force, the joint has to carry a large horizontal shear force (Figure 1) in order to

Figure 1. Horizontal shear force in joint core.

equilibrate moments acted by framing beams. Concurrently, the longitudinal beam bar in the joint is also subject to a large bond stress. As a result, the joint commonly fails by either joint shear or bar pull-out failure.

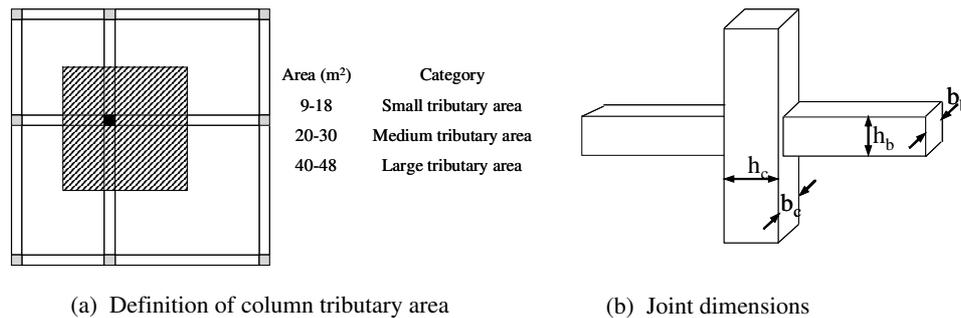
The buildings were grouped into three categories based on column tributary area (Figure 2(a)), as buildings with large, medium, and small column tributary area. Based on the collected data, the area range was set to 40-48 m², 20-30 m², and 9-18 m² for the large, medium, and small category, respectively. In order to characterize the structural behavior of beam-column connections, the structural and geometrical indices were defined for beam, column, and beam-column joint. The structural indices of beam included tension and

Figure 2. Definition of column tributary area and joint dimensions

compression reinforcement ratio, shear span-to-depth ratio, flexural capacity-to-shear capacity ratio, and transverse reinforcement ratio. The structural and geometrical indices of column included axial force ratio, shear span-to-depth ratio, flexural capacity-to-shear capacity ratio, longitudinal reinforcement ratio, and transverse reinforcement ratio. The structural and geometrical indices of beam-column joint included column depth-to-bar diameter ratio, column width-to-beam width ratio, column depth-to-beam depth ratio, confinement reinforcement index, column flexural capacity-to-beam flexural capacity ratio, and joint shear-to-joint shear strength ratio. Figure 2(b) illustrates the definition of joint dimensions used to calculate these indices.

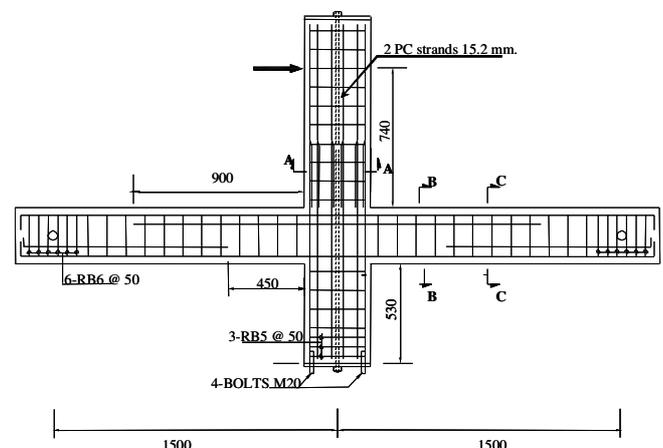
men dimensions and reinforcement details are illustrated in Figures 3-4. The size of the column in the direction of loading is 400, 350, and 300 mm, respectively. However, the beam depth was kept constant in all three specimens to keep the ratio of beam height to column height close to the collected data as shown in Table 2-4. The 12-mm diameter reinforcing bar was used as a longitudinal reinforcement in beam and column. The average tested yield and tensile strengths of the bar were 499 and 615 MPa, respectively. The 3-mm diameter plain mild steel bar was used as a transverse reinforcement in beam and column. The tested yield and tensile strengths of the bar were 291 and 339 MPa, respectively. The average tested compressive strength of a standard concrete cylinder at 28 days was 26.7 MPa.

Figure 3. Geometry, dimension and reinforcement of all specimens (unit:mm)

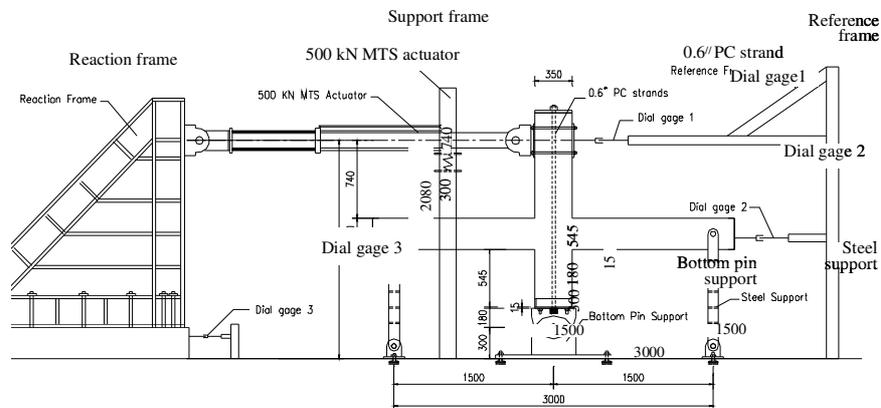
The test set-up and boundary conditions are shown in Figure 5. The lateral forced displacement was applied at the top of the column through a 500 kN hydraulic actuator. The ends of the beam were supported by rollers that allowed free horizontal movement to simulate lateral drift. The bottom end of the column was supported by a hinge which allowed no movement in any direction. The axial load of

12.5% of column axial capacity was applied to the column by means of vertical prestressing. The column was pushed forward and pulled backward in a reversed cyclic. The load type was quasi-static with the load application rate of half an hour to complete one cycle. The lateral drift ratio, defined as

Figure 5. Test set-up

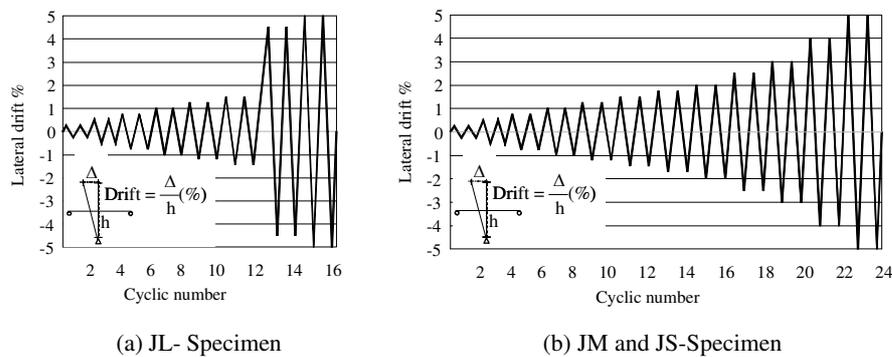
the ratio of the lateral displacement at the top of the column to the column height, was incrementally applied at 0.25%, 0.50%, 0.75%... as shown in Figure 6. The target loop was repeated twice for each drift level. The load was continued until and beyond the peak load to trace the post-peak behav-

Figure 6. Displacement history of each specimen

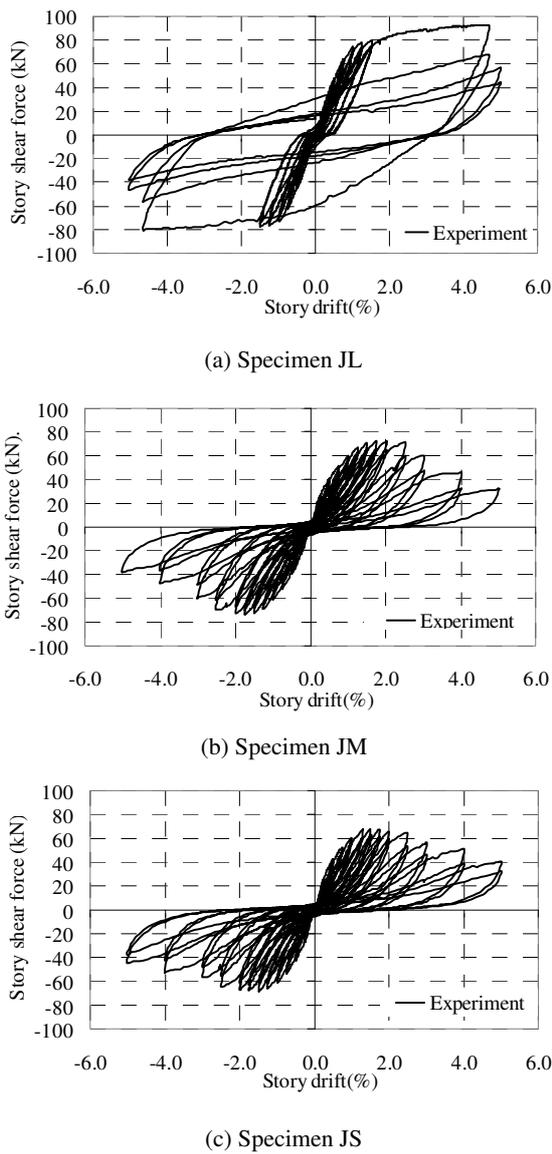
these initial drifts as shown in Figure 7(a). The flexural cracks grew in size and number as the drift ratio increased. The beam yielded at 1.0% drift. The first diagonal crack at the joint was observed at 1.25% drift. Bond splitting cracks were also observed at the longitudinal steel level. The beam maintained yielding up to 4.6% drift when substantial crushing of concrete at the beam compression zone took place and spalled off, exposing beam bars as shown in Figure 8(a). The specimen lost its strength abruptly. Throughout the entire loading, no cracks were observed in the column lap

Figure 7. Relationship between applied load and displacement of each specimen

splice region above the joint. No damage was observed in the joint except some few joint shear cracks. The failure of the beam was classified as ductile flexural failure. The hysteresis loops were wide, indicating large energy dissipation in bending mode. It is noted that even though the specimen lacked ductile reinforcement details and was not designed to resist seismic load, it could perform fairly well. The good performance was supposedly attributed to the size of column which was comparatively large, in order to support large gravity load for the large tributary area. As the column size is large, the joint shear stress has decreased naturally, and the bond demand of the column lap splice is relieved. The bending failure then occurred in the beam according to strong column weak beam principle. This experiment demonstrated that the performance of beam-column joint was

The behavior of JM and JS was similar, hence they are discussed together. The flexural cracks were observed in the beam in the beginning of the 0-0.25% drift ratio (Figures 7(b), 7(c)). The first diagonal crack was found in the joint core at 0.5% drift ratio. They formed an X-pattern following the alternate load directions. The flexural cracks in beams and the diagonal cracks in joint cores continued to grow in size and number until the specimen reached the peak load of 72 kN at 1.75% drift ratio for specimen JM, and 68 kN at 1.5% drift ratio for specimen JS. After this cycle, no new cracks were found in the beam, but diagonal cracks continued to widen in the joint core. This was followed by spalling of concrete at the center of the joint area. At 3% drift, the concrete spalling extended throughout a wider area of the joint, exposing column longitudinal bars. The test was continued until 5% drift ratio, where concrete spalling covered

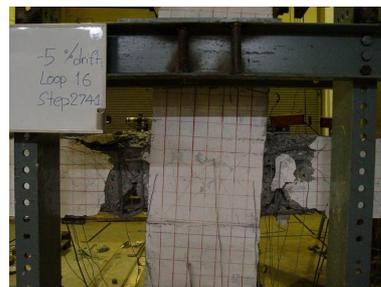
(a) Failure of specimen JL

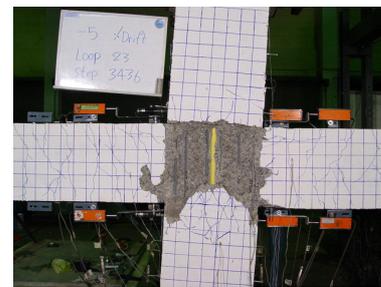
(b) Failure of specimen JM

the entire joint area (Figures 8(b), 8(c)) and extended into the column above and below the joint. The failure mode of JM and JS could be classified as joint shear failure. It should be noted that no damage was observed at the column bar splice region above the joint. The joint shear failure is not desirable as it is abrupt and results in pinched hysteresis loops with low energy dissipation. The experiment indicated the vulnerability of existing buildings with small column tributary area. Future research should look into the retrofiting of these classes of buildings.

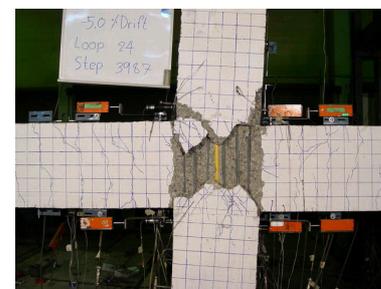
(c) Failure of specimen JS

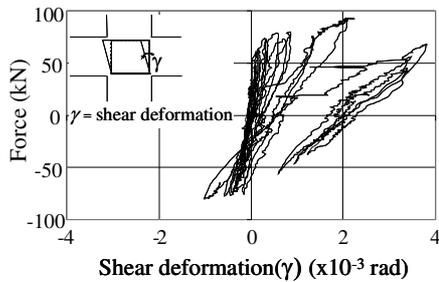
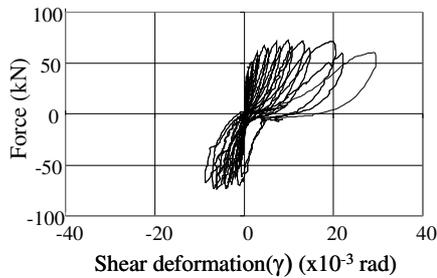
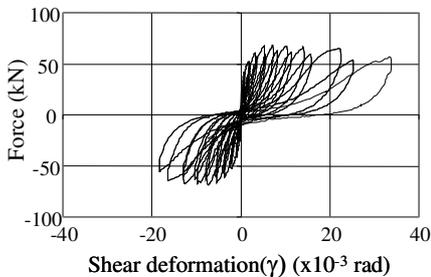
To gain an insight into the behavior of each specimen, local deformations and strains were measured at critical regions of the specimens. The force-shear deformation in the joint zone is compared among three specimens in Figure 9. The joint shear deformation was plotted in terms of shear angle. Specimen JL showed clearly smaller joint shear de-

formation compared with JM and JS. The maximum values of shear deformation at failure were 0.00012, 0.02 and 0.015 radian in JL, JM and JS, respectively. These shear deformation values correlated well with observed damage level in the joint of each specimen. Little shear inelasticity was observed in JL, while substantial damage existed in joints of specimen JM and JS. On the other hand, the hysteresis force versus shear deformation of JM and JS showed severe pinching, which partly accounted for the pinching of the global load displacement relation.

Figure 9. Force- joint shear deformation relationship of each specimen

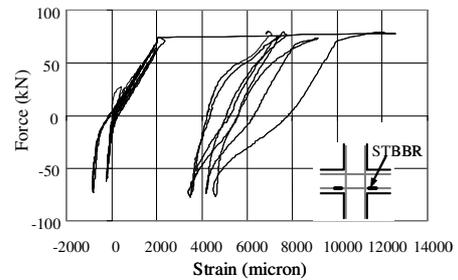
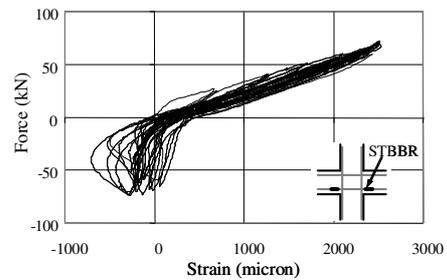
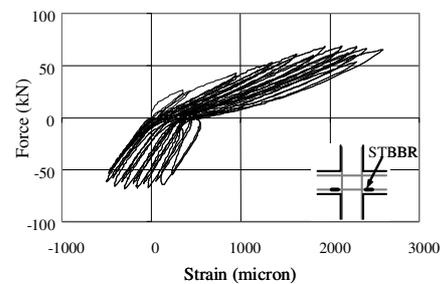
The force and strain relations of bottom bars located 50 mm away from the joint face (STBBR-gage) and at the middle of the joint (STBBM-gage) are plotted in Figures 10 and 11. Specimen JL reached yielding and developed large plastic strain, while JM and JS merely reached yielding without developing high plasticity. In each specimen, the

Figure 10. Strain of bottom beam bar (STBBR) at 50 mm away from the joint face

strains of bottom beam bars at 50 mm from the joint face and at the middle of the joint showed obviously different behaviors. At 50 mm from the joint face, the steel bar of JL was subject to alternate compressive and tensile strains in the early drift levels. But the strains turned into purely tensile at high drift levels regardless of the loading direction. As for JM and JS, the strain behavior on the tensile and compressive sides was obviously unsymmetrical. This is due to the fact that the strain of the steel bar was smaller on the compressive than on the tensile side. With increasing drift ratio, the tensile strain continuously increased, whereas the compressive strain (negative strain value) initially increased, but gradually decreased later. This behavior was dealt with by the interface pull-out crack, which was caused by local bond deterioration, and had taken place in the previous opposite load direction. During reverse loading, the pull-out crack was not completely closed, thus, a positive strain value still remained in steel, and was accumulated in subsequent cycles. The steel on the compression side became positive instead

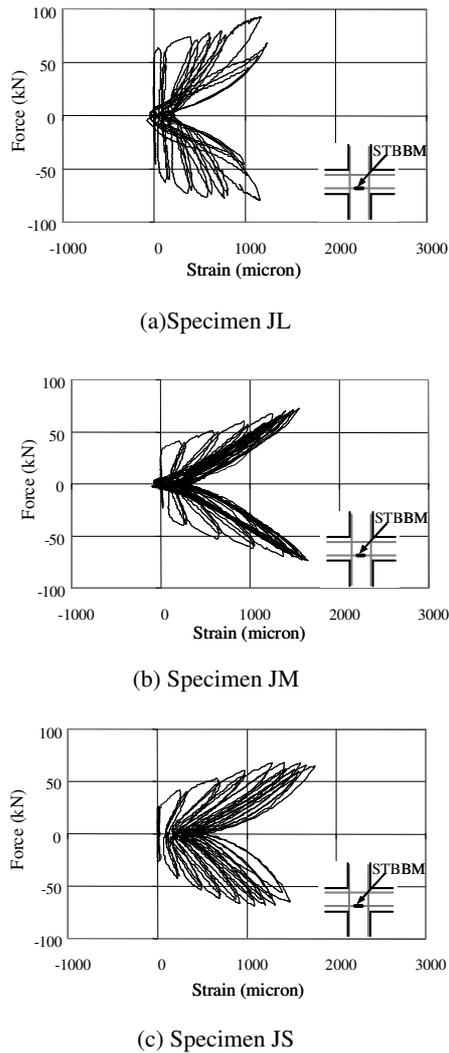
Figure 11. Strain of bottom beam bar (STBBM) at the middle of joint

The behavior of the steel bar at the middle of the joint showed a butterfly pattern. The strains on the compression and tension side were symmetrical at about zero force level. The steel strain at the middle of the joint of all specimens was always tensile regardless of the load direction. Furthermore, it should be noted that strains at the middle of the joint were approximately equal in all specimens, and that the magnitude was less than the yield strain. As seen for all specimens, the yielding did not spread deep into middle of the joint. This was contrasted with the value at 50 mm away the column face, especially for the steel strain in JL. This indicated that the bond within joint core was not completely lost along the length of the bar. The variations of strain with load cycles are plotted in Figures 12(a)-12(c). Specimen JL maintained bond conditions quite well before yielding at 1.25% drift ratio. After yielding, the bar strain was purely tensile, indicating the local loss of bond at the section with high strain value. For Specimen JM and JS, the local bond was lost in the early 0.75% drift.

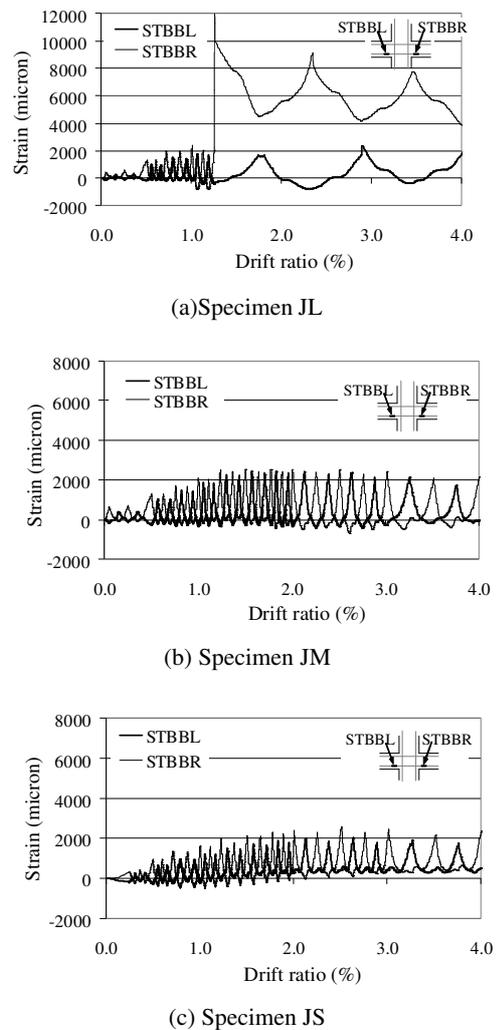
Figure 12. Strain history of bottom beam bar at 50 mm away from the joint fac
